# Manitou Boatworks & Engineering

## Marine Surveying and Consulting

## SUMMARY

On June 29, 2007 I performed a Condition and Valuation Survey on a 1997, 370 Sea Ray Sundancer. The vessel was docked at Northwest Marina in Charlevoix, Michigan. The vessel was delivered to Irish Boat Shop in Charlevoix for a haul-out the same day. The vessel's underside was inspected and then delivered back to Northwest Marina. The vessel was found to be in above average condition with a few issues that are discussed in the survey.

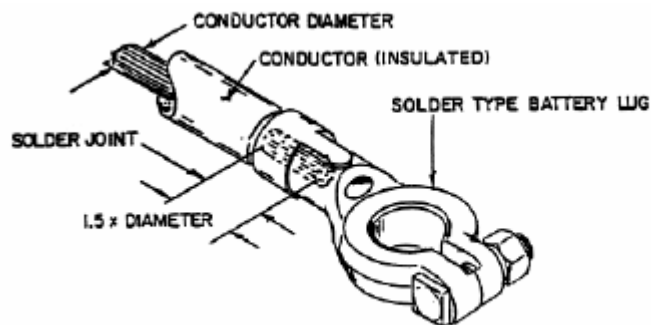
### 10.8 WIRING

The vessel was equipped with a DC and AC electrical systems. The AC and DC systems were visually inspected with some of the equipped operated. The vessel was connected to shore-power while the vessel was at the dock. The 12-volt DC system contained five batteries, which were connected as three different banks. The batteries were stored above the bilge sole in the engine compartment. The batteries were secured using battery trays, though no lids were used. The batteries did not contain any purchase dates; and were not load tested during the survey. All battery cables appeared in good condition with no corrosion or damage. The terminal connectors on the cables were standard at the time of production, though under today's standard an enclosed connector is recommended. I have attached an ABYC drawing under the recommendations.

- Replace rubber gasket around anchor locker
- Reseal stainless steel anchor pulpit and chain guards on deck
- Seal small hairline cracks in gelcoat around starboard, above waterline exhaust thru-hull
- Inspect bilge area under water heat, make sure area is not trapping water
- Make sure water does not continue to penetrate firewall bulkhead
- Service fire extinguisher system (Halon) and label with service dates
- Reseal underwater exhaust thru-hulls
- Reseal transom drain plug and zinc mount
- Reseal port trim tab
- Tighten and reseal, second from aft, stanchion deck plate on port side
- Check for coolant leak on starboard and port engine
- Check for small oil leak on starboard engine
- Battery cable connectors used leave exposed cable, I would recommend that the example below be used

10.8.1 Battery wiring shall conform to the Installation section of [ABYC E-11, AC and DC Electrical Systems On Boats](#).

10.8.2 Connectors to battery terminals shall be made with fitted connectors providing secure mechanical and electrical connections as required in the Wiring Connections' section of [ABYC E-11, AC and DC Electrical Systems On Boats](#). Spring clips or temporary clamps shall not be used.
